Second spin Casting test - December 17th,2004

A second test was conducted to look at how the introduction of powdered graphite into the molten paraffin before spin casting would affect the final product.

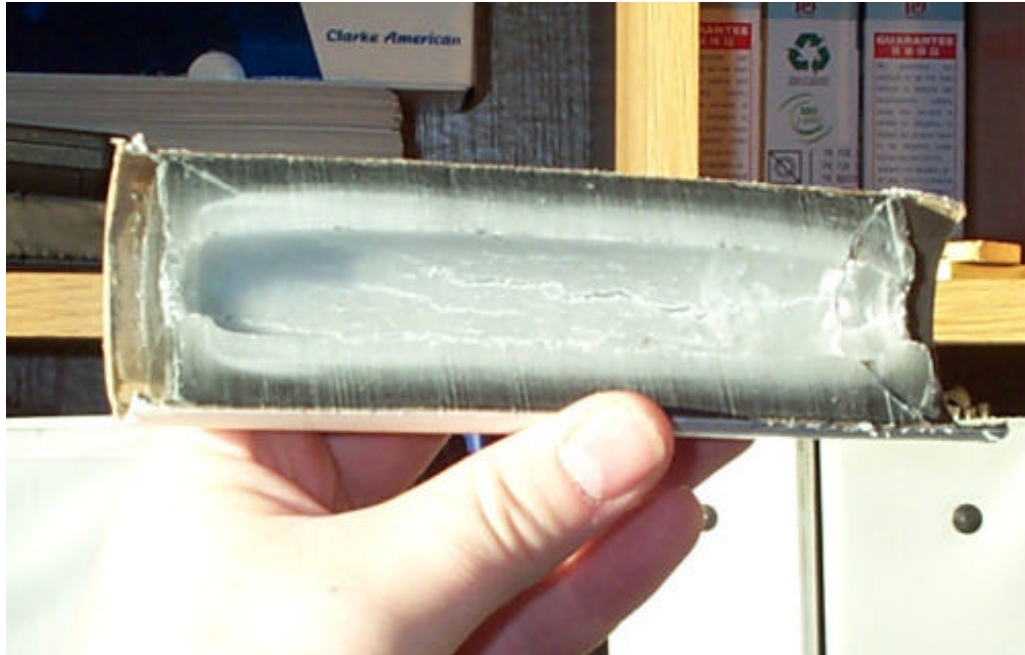
This was found to be true in this test. The above picture shows a much higher graphite concentration near the outer walls of the fuel grain. The graphite concentration decreases as we move in towards the port of the grain. The distribution of graphite does not seem to be a linear distribution, but in this particular test there almost seems to be 3 discrete regions. A black band, a grayish band, and a white band...not sure what to make of this.

This most recent grain pictured above only has minor interior surface cracking that probably does not exceed 0.05 inches in the worst case. The only other crack is a major fault line at one end of the grain. This domed or semi-conical portion of the grain actually came out when the end plugs were being removed. An identical fracture occurred on the first grain but was thought to just be a random crack in the paraffin that was aggravated by the act of cutting the grain in two.

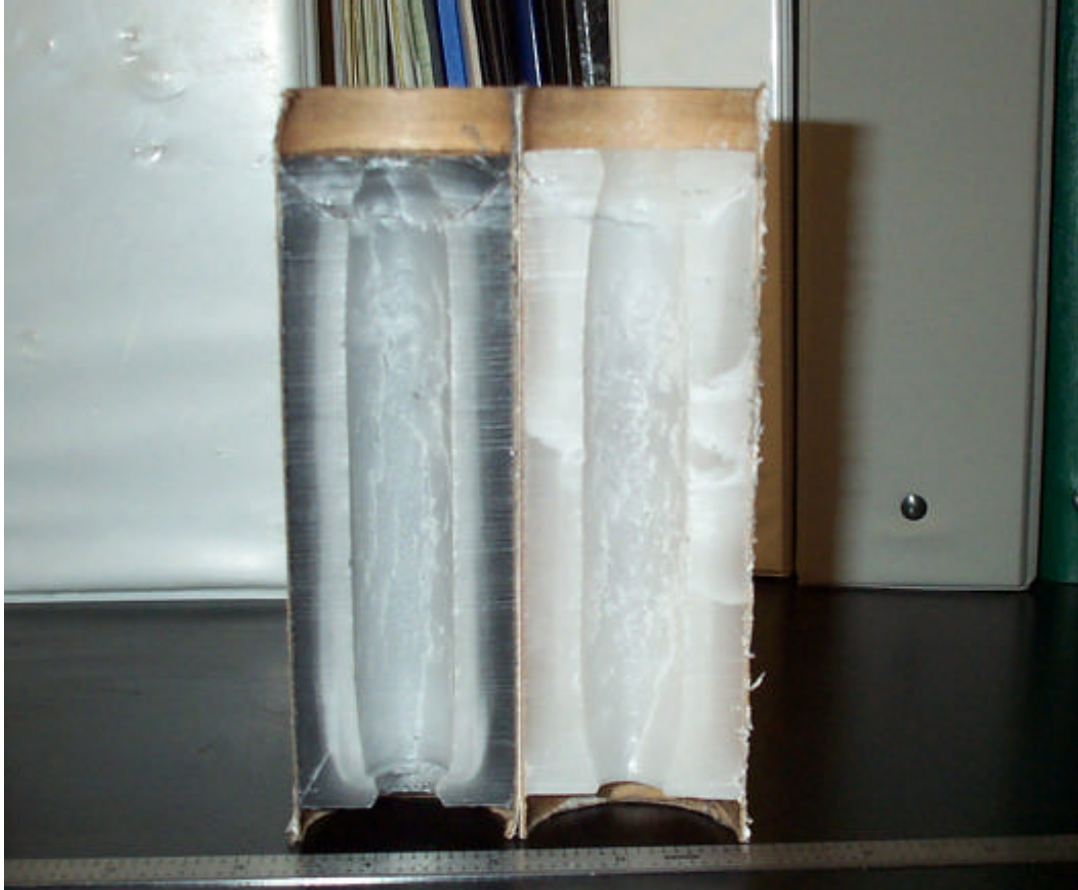
As can be seen in the following picture the faults are in the same position in both cases.

In both cases, this is this region of paraffin is in contact with the aluminum plug that is on the motor end of the spin caster. We will perform another test and see if this happens again. It may have something to do with the nature of the cooling of the grain near the plug or it may have to do with the disassembly of the grain holder after cooling has occurred.
