**PSU AESSE
LV1b IMU Analog board
Rev. 1.5 8/14/00**

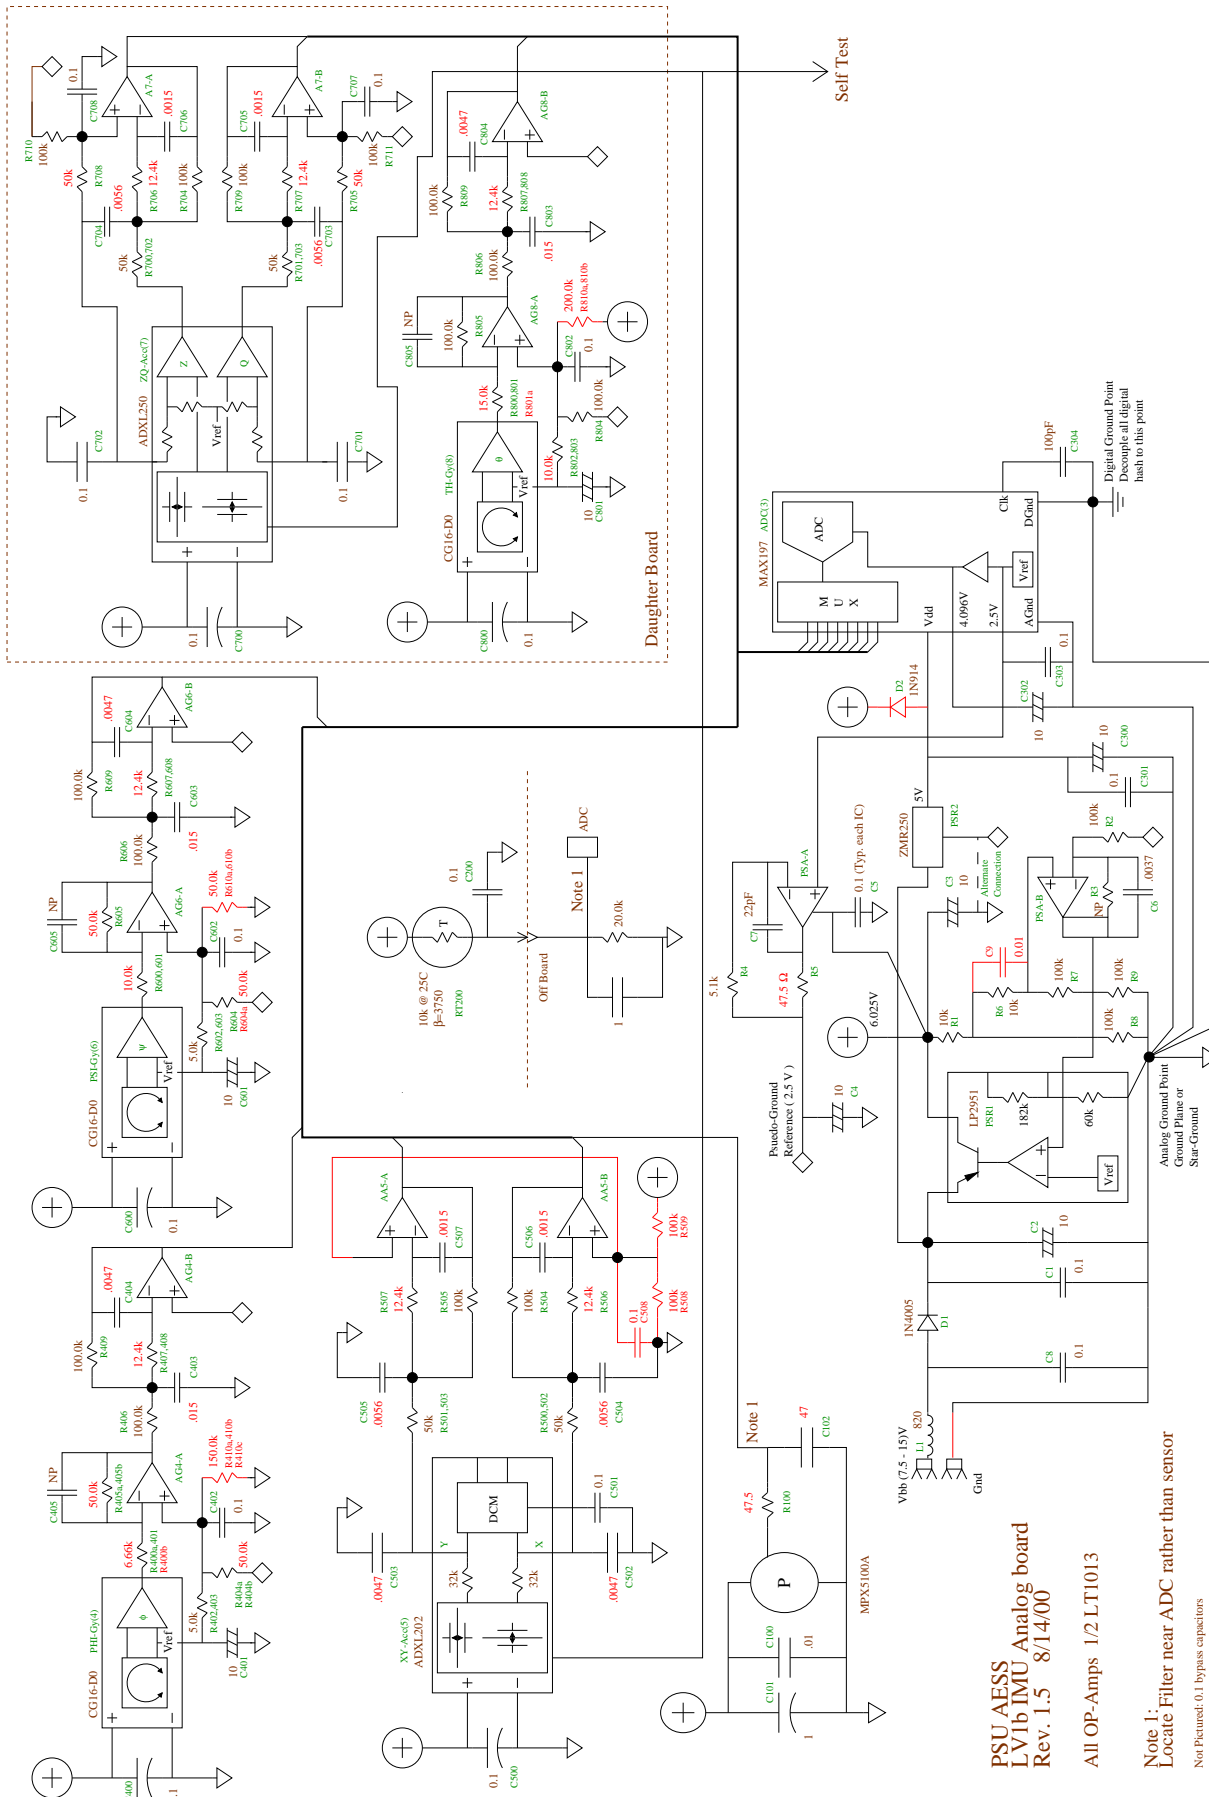
All OP-Amps 1/2 LT1013

Note 1:
Locate Filter near ADC rather than sensor

Not Placed: 0.1 bypass capacitors
C9, C466, 407, C508, C606, 607, C709, C806
